THE RESTORATION OF THE KRISHNA TEMPLE

PATAN - NEPAL

2015 - 2018

NEETA DAS

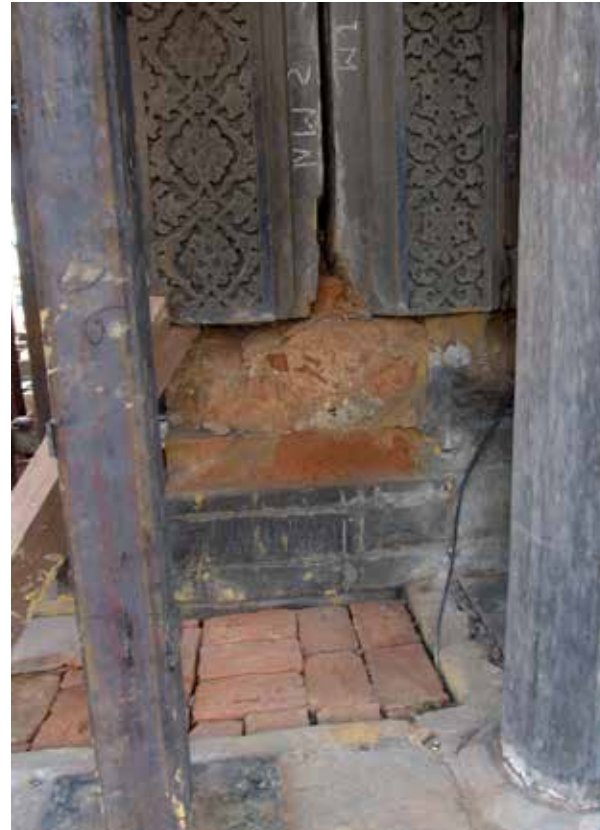
Left Top
Damaged threshold stone at
southeast corner of innermost
sanctum (*garbha griha*). Vertical
shoring, using "I" section columns
with iron base plates have been
added in the four corners of the
second floor (Shiva Temple level)
to provide additional support
for the upper structure and to
allow for in situ repair of the out
of plumb columns in the four
corners and replace the base of
corner columns.
(Photo: KVPT. Nov. 23, 2016.)

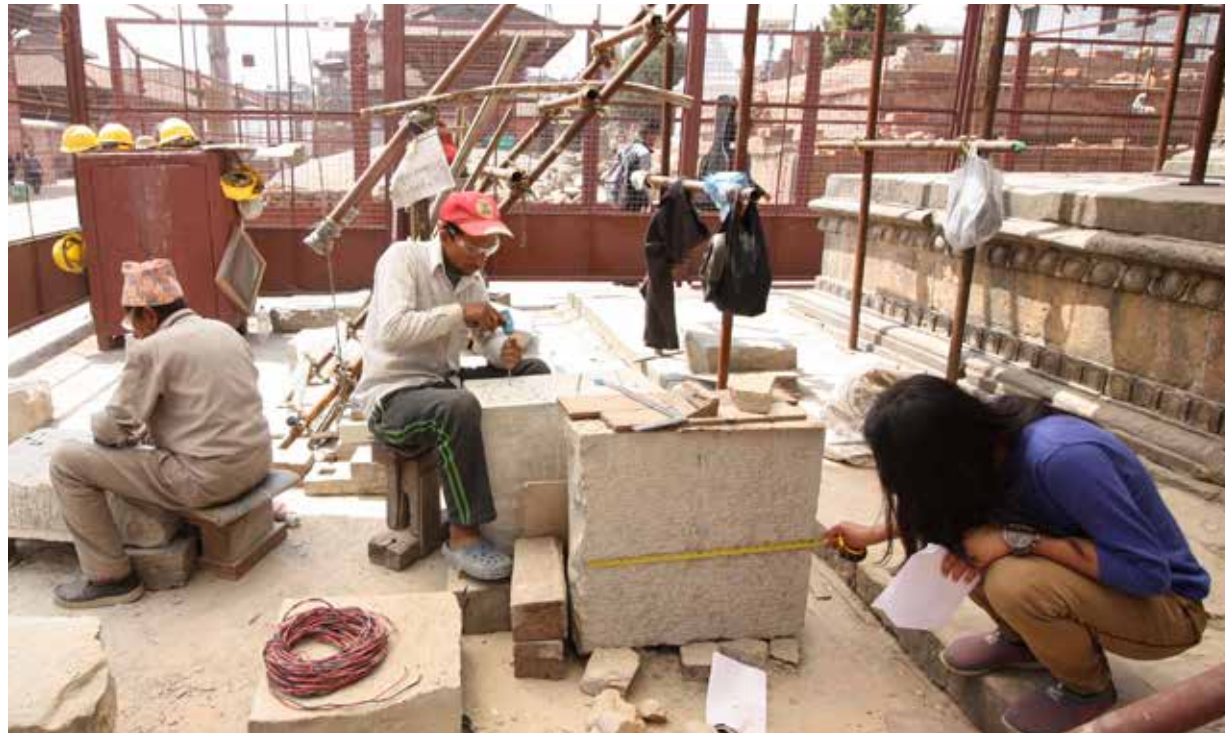
Left Top
Stone mason Asha Bahadur Ranjitkar preparing a new stone to replace the corner damaged piece on the Shiva Temple level. (Photo: KVPT. Jan 24, 2017.)

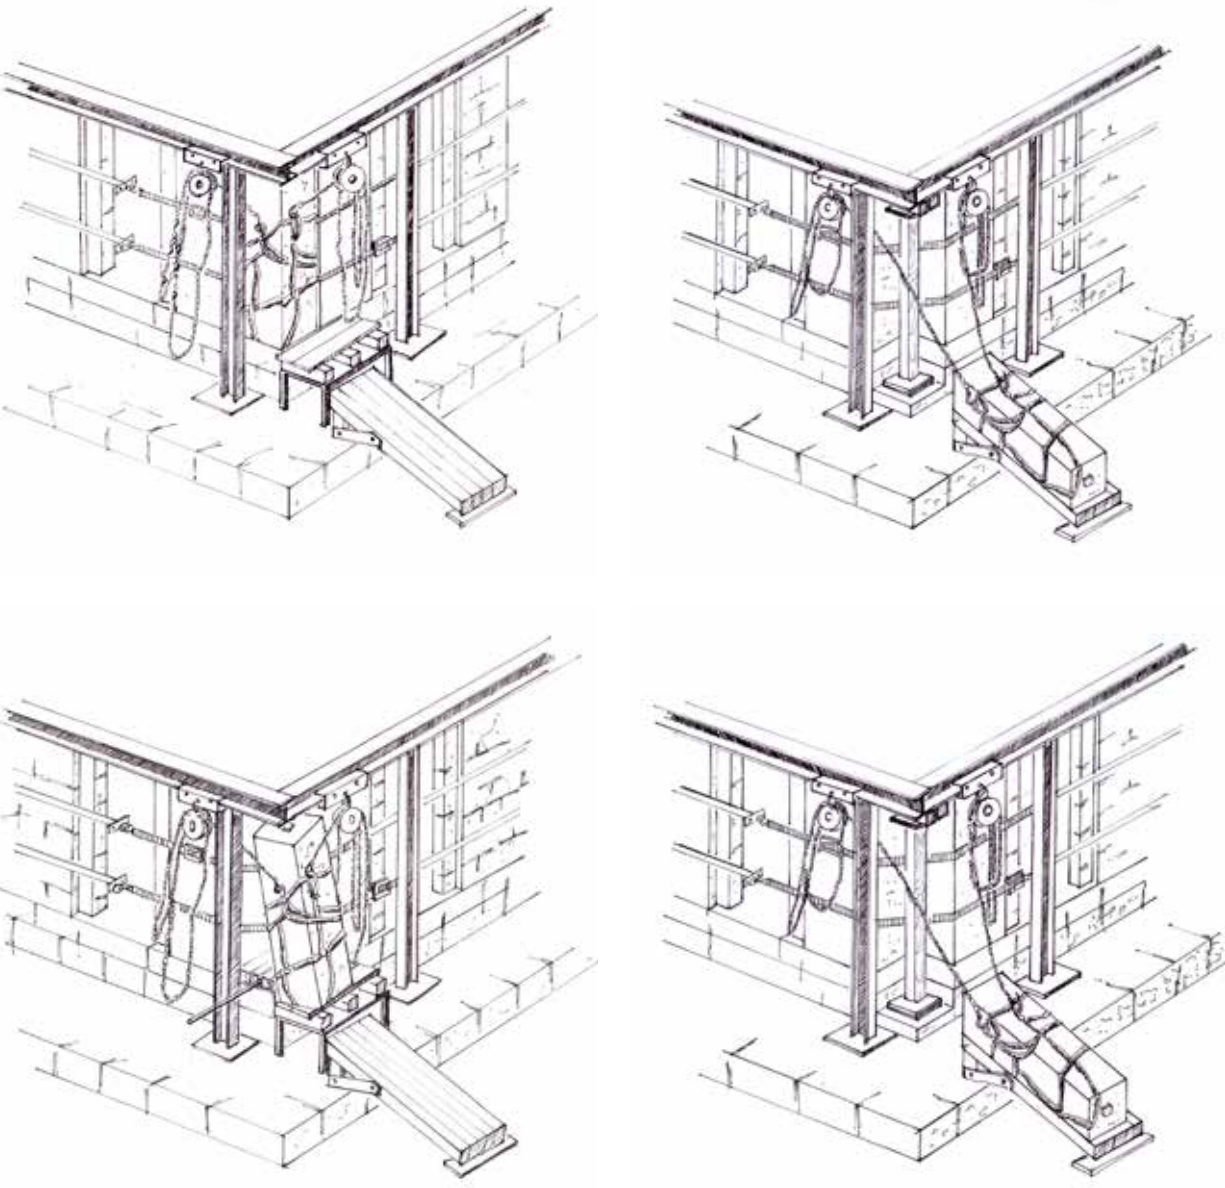
Top Left:
Southwest corner stone strapped,
connected to the chain pulley
system and ready for removal.
Steel angle belt has yet to be
removed.
(*Photograph by E. Speer, March 2,
2017.*)

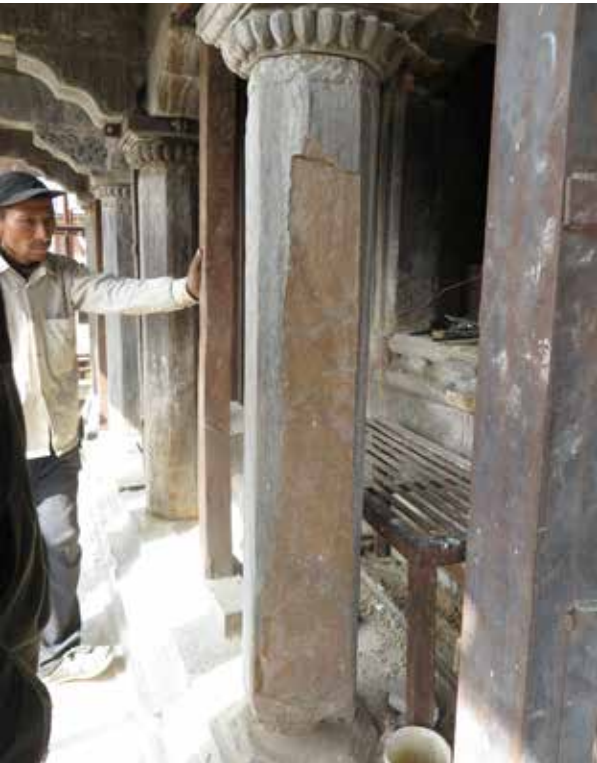
Many of the 20cm (8”) octagonal columns experienced movement during the earthquake and do not properly align with the capital elements. Some capitals experienced loss of section, and one column in particular, on the south line of the inner colonnade, one column experienced extensive damage. It is stipulated that this column was likely made with a lesser quality stone, and its origin is unknown.

Loss of section of the column, combined with being out-of-plumb, means that this column must be replaced. A replacement to this type of column should include a vertical fiberglass or stainless steel dowel extending from the beam to bracket to capital to the column shaft, and also from the column shaft to the base. This would allow the energy dissipation of the rocking of stone elements, but would retain the load path and resist the dislodgement of the stone elements by providing vertical continuity.

There was hesitation in the site team to replace this column, due to concern about the shoring and relieving the load. In January 2018, the team on site proposed to patch the octagonal column as a temporary measure, but ultimately the column should be replaced.

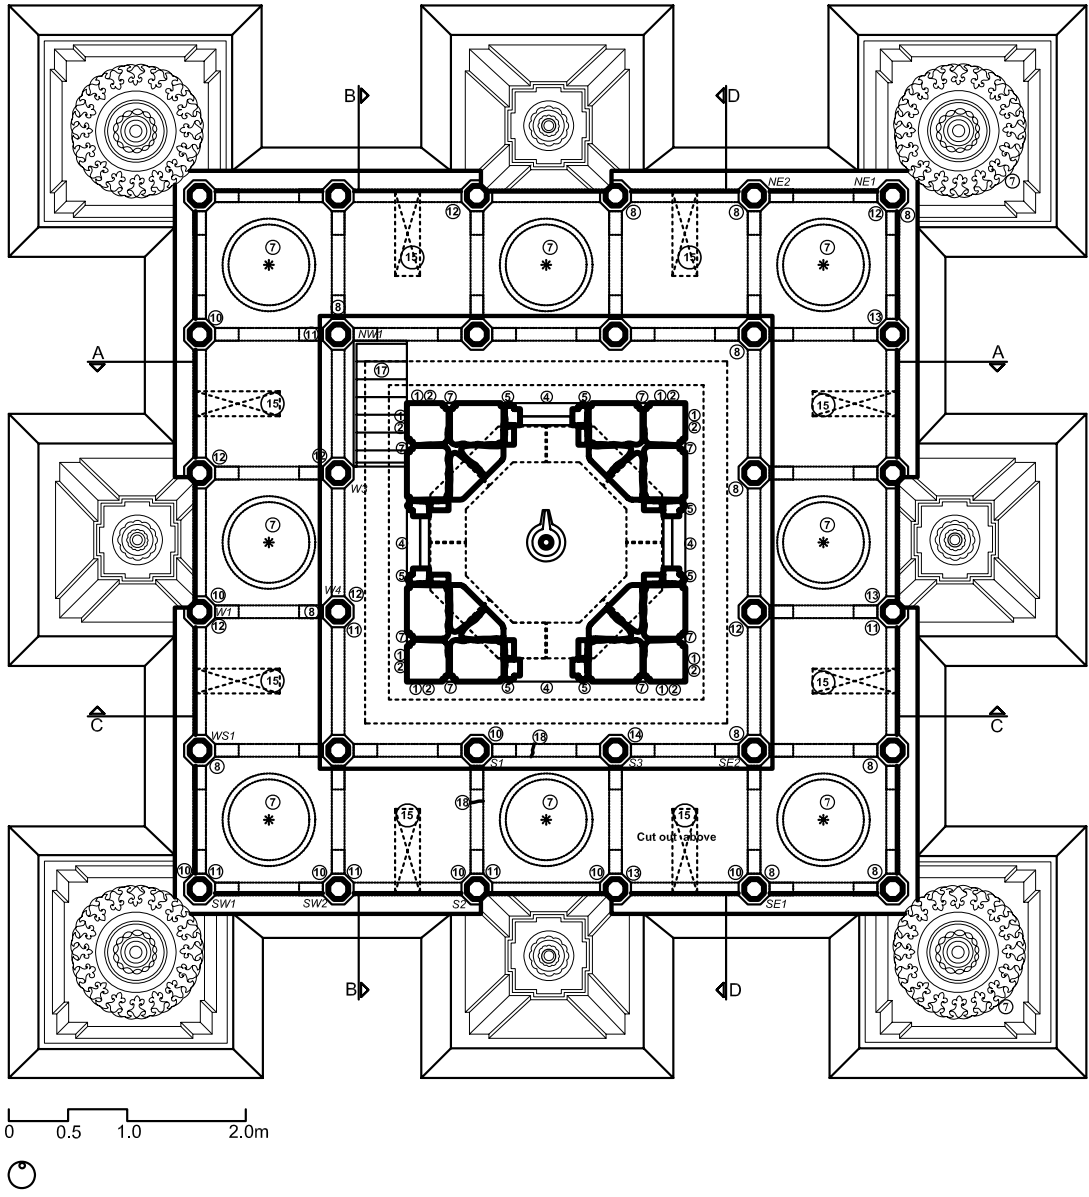
Second Floor Plan Drawing Indicating Damage and Reference Numbers For Photographs
Drawing by Nilufa Rahman and Suchismita Bhattacharya, 2016

Identification of Damages	
1.	Damaged and out of plumb corner stones of garbha griha
2.	Damaged stone and carving
3.	Damaged stone
4.	Dislocated/Fallen key stone
5.	Dislodged window frame
6.	Loose /Broken stone window jaali
7.	Open joints
8.	Old repair damage
9.	Cleaning of garbage and stacking archaeological remains
10.	Out of plumb columns
11.	Dislocated brackets
12.	Damaged column capital
13.	Damaged column base
14.	Damaged column shaft
15.	Tin shed addition
16.	Damaged pointing in all floors
17.	Damaged tread stones in staircase
18.	Crack in beam
19.	Damaged pinnacle

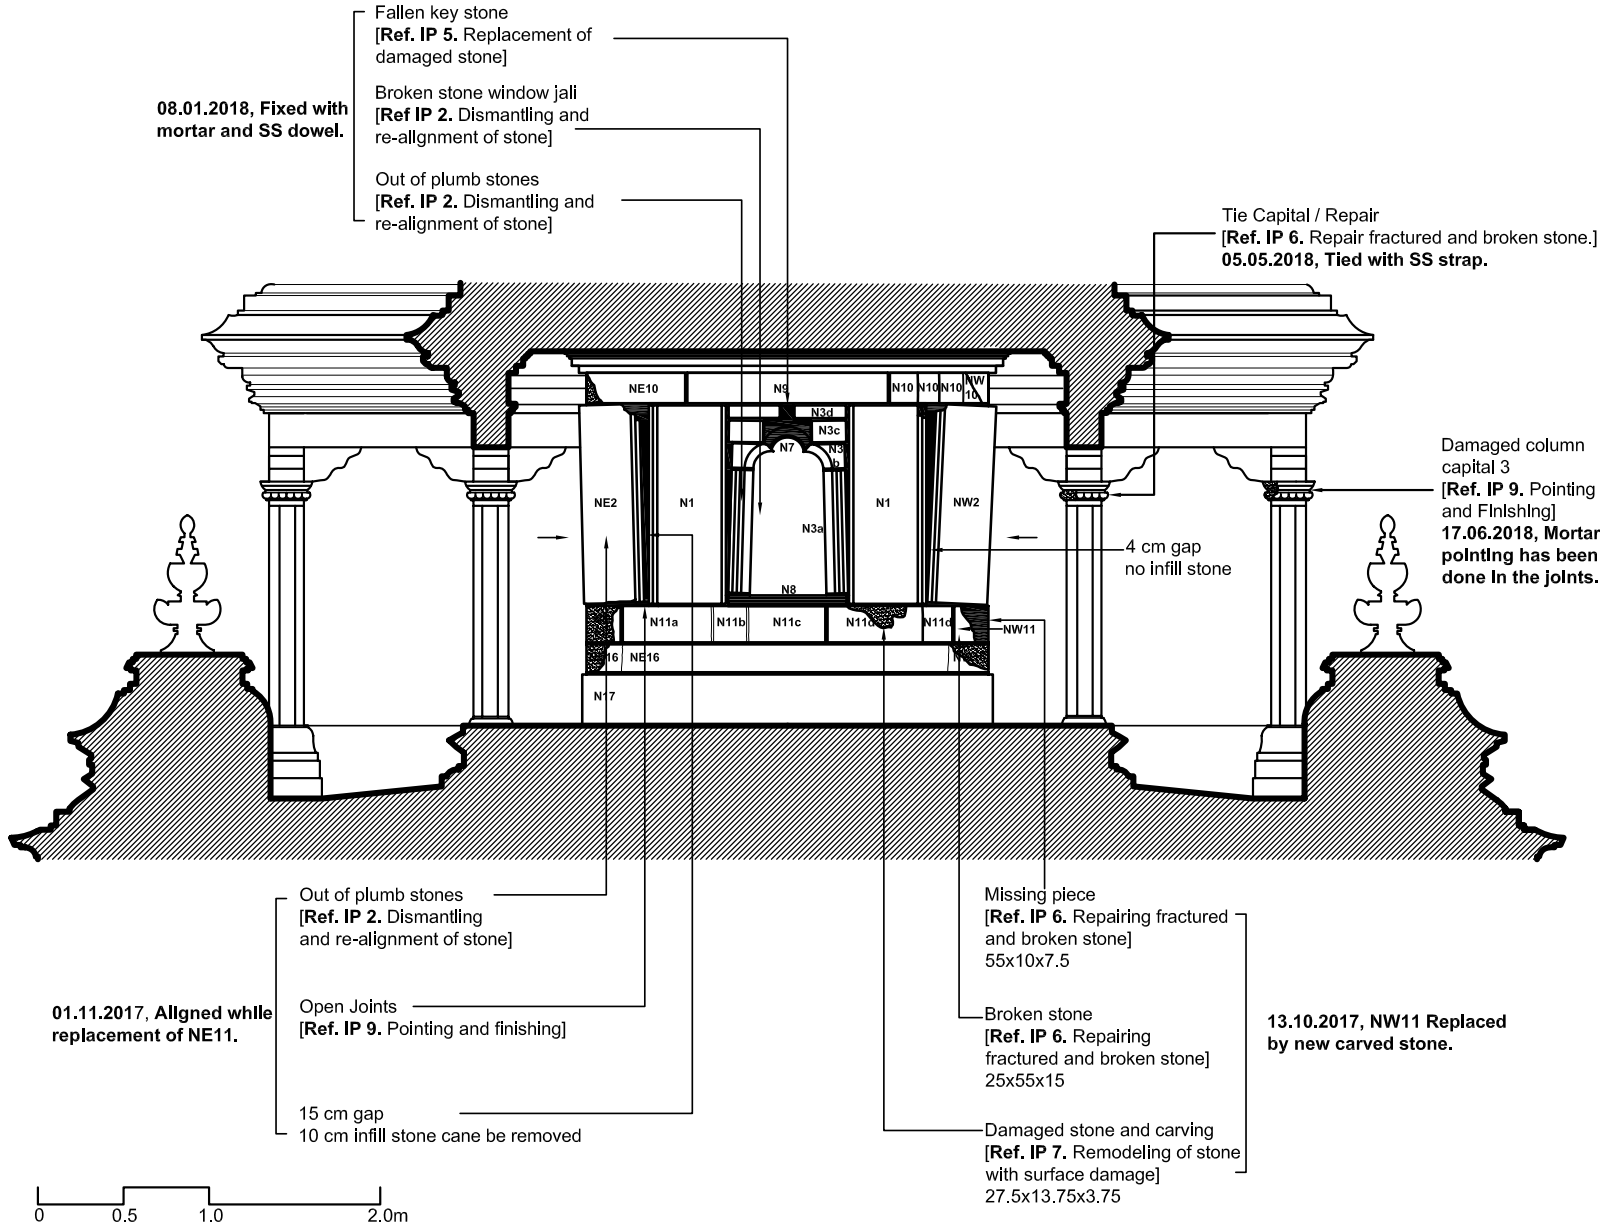
North Side Sectional Elevation AA

Indicating Damage and Details of Repair on North Face

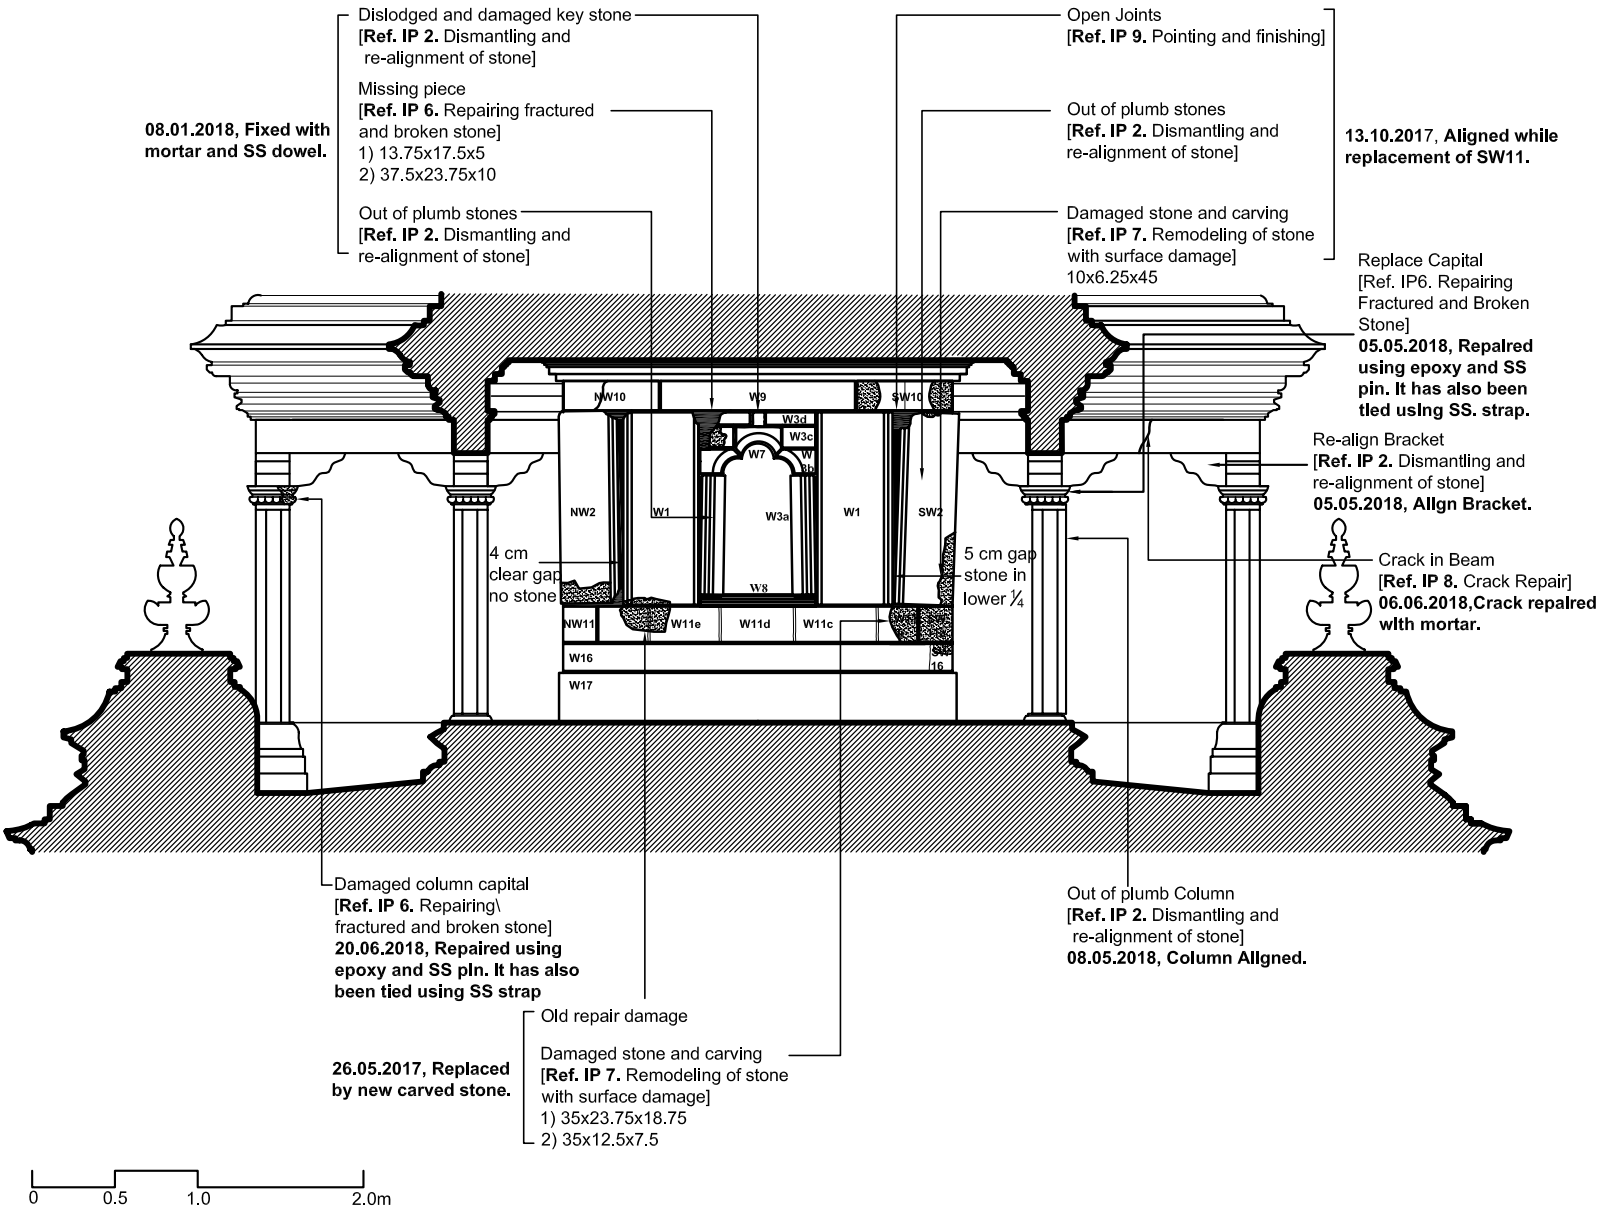
West Side Sectional Elevation BB

Indicating Damage and Details of Repair on West Face

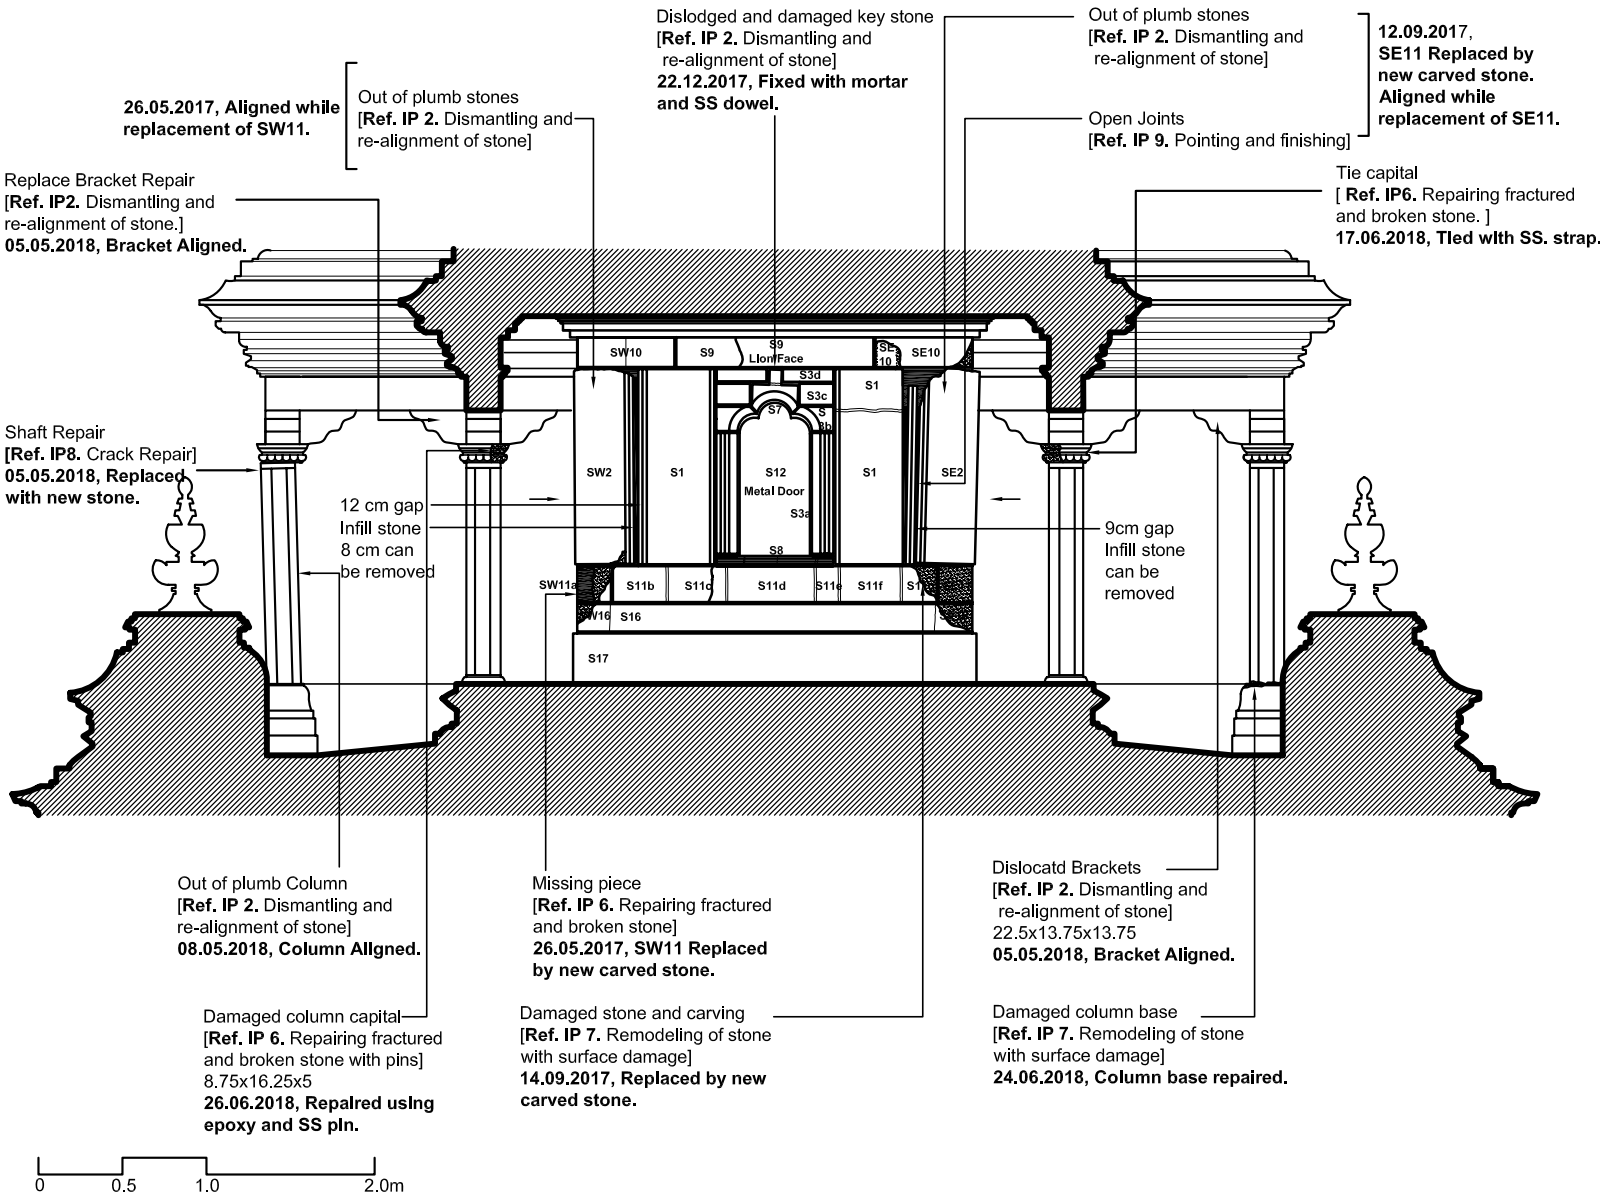
South Side Sectional Elevation CC

Indicating Damage and Details of Repair on South Face
Drawing by Nilufa Rahman & Suchismita Bhattacharya, 2016

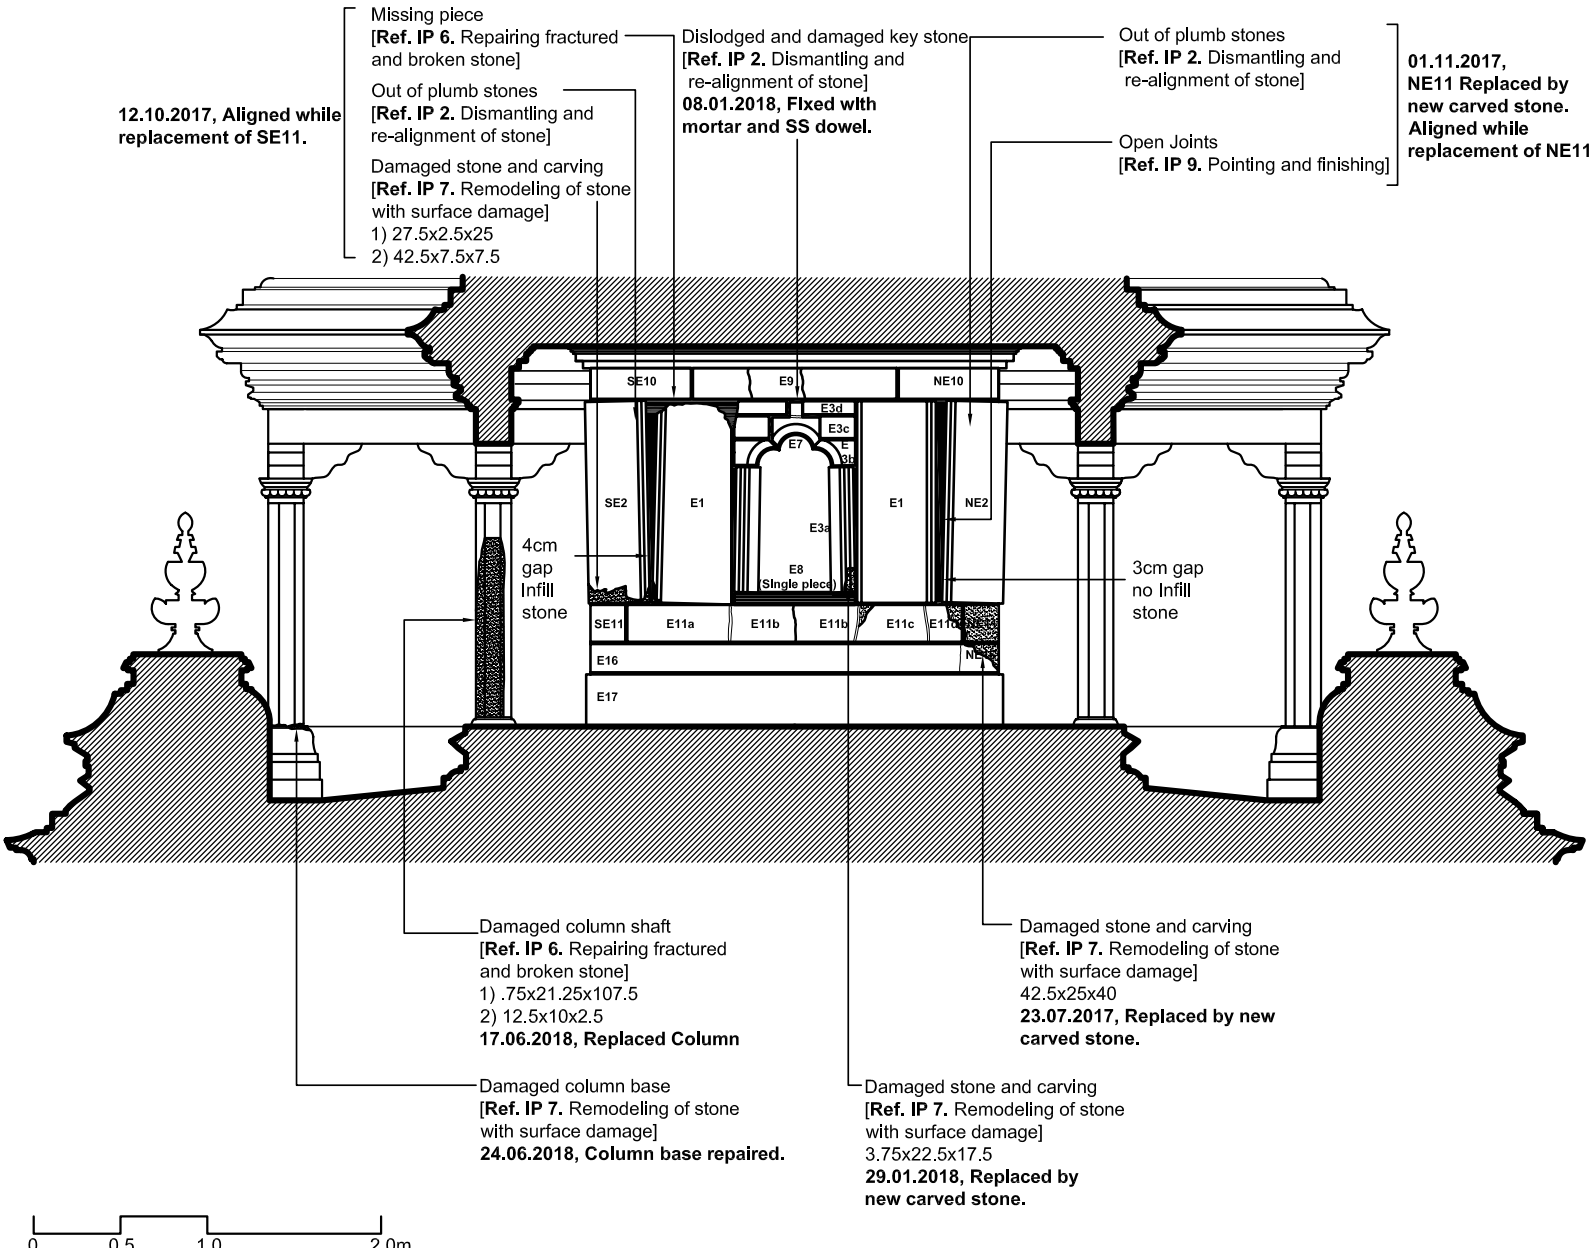
Indicating Damage and Details of Repair on East Face
Drawing by Nilufa Rahman & Suchismita Bhattacharya, 2016

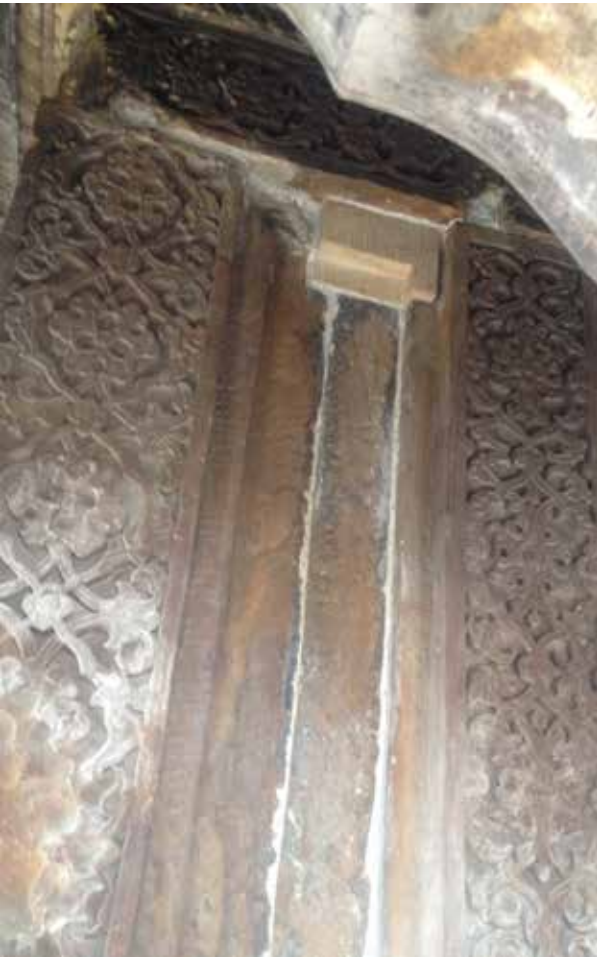
Large openings and joints

Due to the movement of the corner stones away from the load bearing stone walls, large gaps could be seen. The core behind the outer wall became visible. Old repair mortar of lime and *surkhi* (brick powder) crumbled out of the open joints. Old repair stone pieces and layers became evident. Since there was no way to inspect the brick core, if any, behind the stone walls, ultra sonic tests were conducted. However, in the absence of proper vantage points for the placements of the nodes, the tests were non-conclusive. Much later, during repairs, when the inner stone wall was opened, no brick core was revealed, flouting the earlier theory.

It was recommended to rake out the old joint carefully by hand in order to avoid damage to the stones. The depth of pointing was to be sufficient to hold the new mortar. Correct tools were to be used for this. It was recommend to flush out the open joint with a jet of clean water, damp it down, and fill with compatible lime mortar as advised. If the joint was too big, some aggregates or stone pieces, of matching colour and properties, were to be inserted to reduce cracking on drying. Care was to be taken to avoid any spilling of the mortar on the stone surfaces to prevent staining. Colour, texture, and thickness of the mortar was to match the original mortar. Natural pigments could be used to give the correct colour. Proper curing was to be done after application.

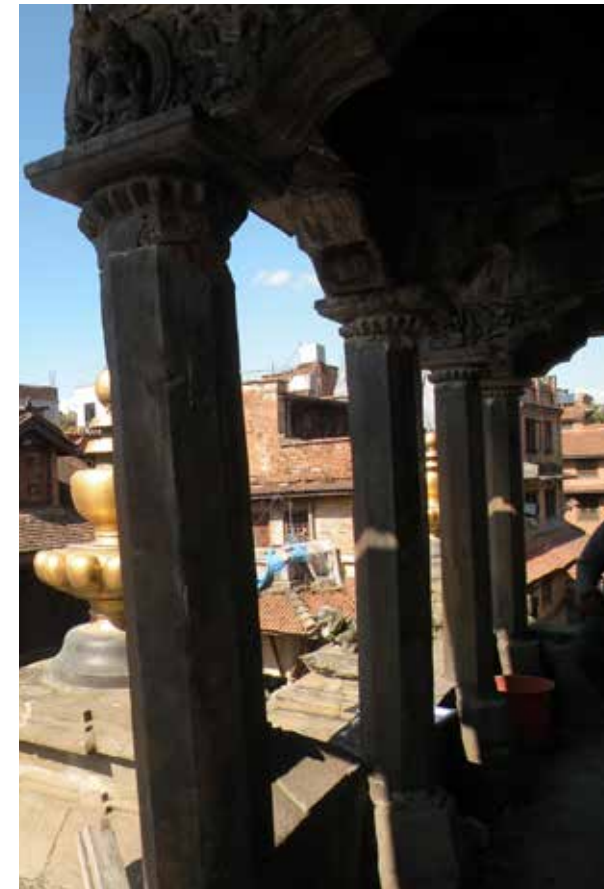
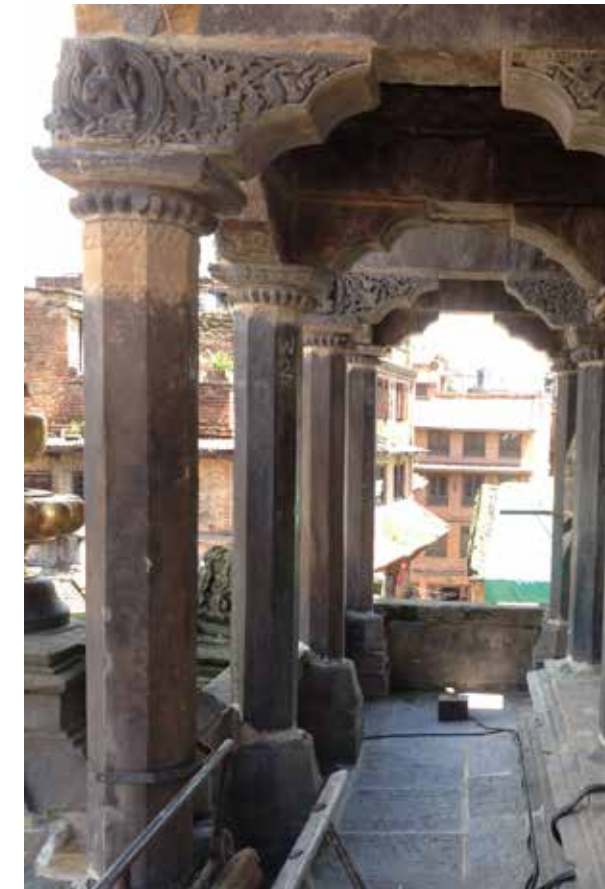
The *garbha griha* is enclosed by two colonnades. The inner colonnade has twelve slender columns and the outer colonnade has twenty slender columns. All columns have a base, shaft, and capital. The beams above are supported on brackets. Due to the lateral movement of the temple during the earthquake, the columns had tilted and were out of plumb . All tilted columns had moved outwards. Seven out of twenty columns on the outer colonnade had tilted, three on the west and four on the south. Columns on the north and east had not

moved at all. Only one column of the inner colonnade on the south side moved, also on the outside.(See Plan)

Left & Center
Out of plumb columns before and after re-alignment.

It was recommended to first brace the columns to prevent any accident. The columns were then to be straightened with the help of a pulley. Temporary protection like bubble wrap and foam sheets were to be tied around the stone to prevent crushing of edges during this procedure. The stone columns were then to be fixed to the bases and capitals with steel pins, mortar, and adhesive as found necessary. Once this was done, the structural system of the temple would become safe.

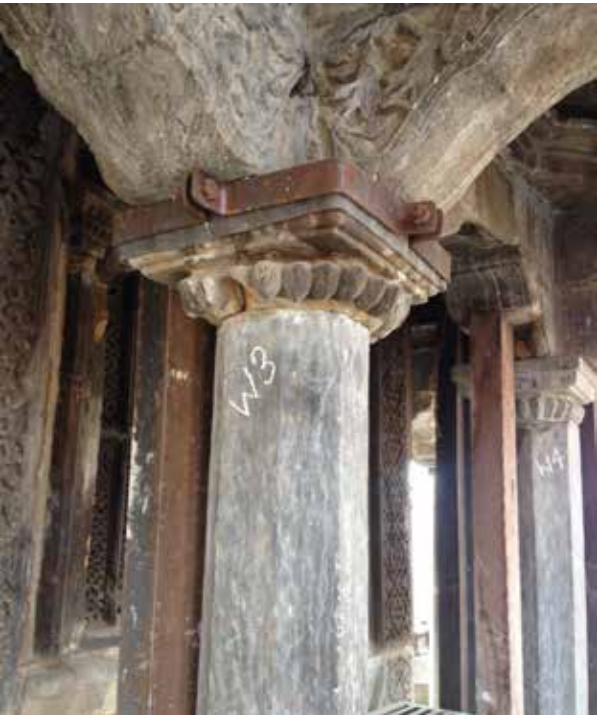
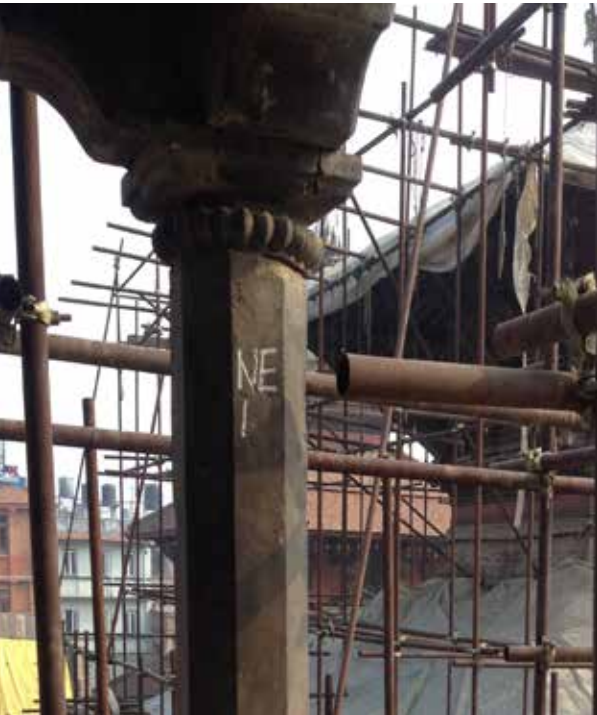
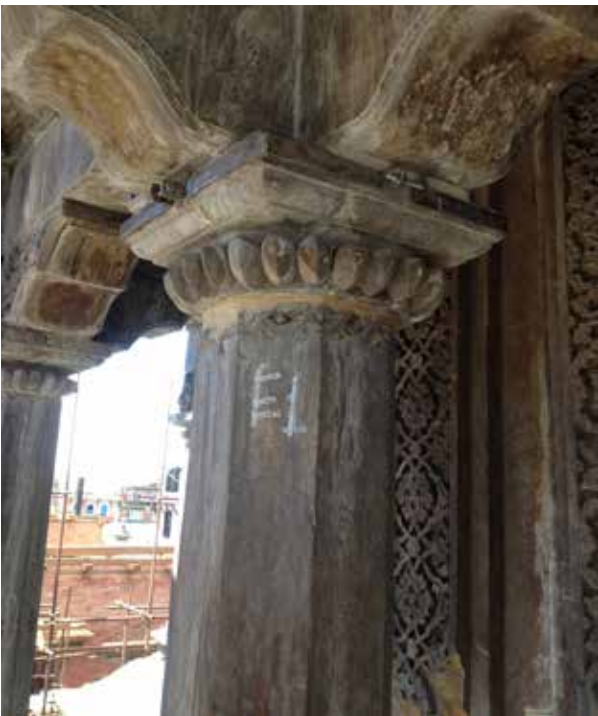
Left Top, Bottom & Center Top, Bottom
Column capitals were restored by pinning, pointing, partial replacement of stone, and where severely damaged or cracked a steel tie was used to hold it together.

It was recommended to first support the beams on both the sides of the column, the damaged capital would have to be replaced in part or whole or repaired after assessment on site. Most of the capitals were carved, but whether the same would be done for the new stones, was a decision that was to be taken later. Fractured capitals would have to be pinned together by using stainless steel threaded bars and epoxy resins. Sometimes pins were not required. At such times patches of structural glue could be used to join the stones. Minor damages could be ignored or repaired with matching mortar.
